# TEST REPORT

No. : SHAM20230703714-1  
Date : Aug.3,2023  
Page : 1 of 3

Sample Name : Lashing Rings  
Sample Number : SHAM20230703714  
Product Specification : Lashing Rings  
Product or Lot No. : DM04025  
Material and Mark : Q235  
Test Required : Proof load test  
Date of Receipt : Jul.25,2023  
Test Period : Jul.25,2023~Jul.26,2023  
Test result(s) : For further details, please refer to the following page(s)

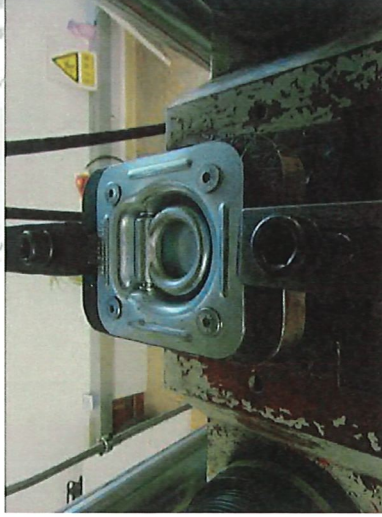
Before test

Test item	Proof load (lbs)	Loading time (s)	Requirement (lbs)	Fracture location
Result	5000	60	≥5000 no fracture	No fracture.
	5170	60	≥5000 no fracture	No fracture.

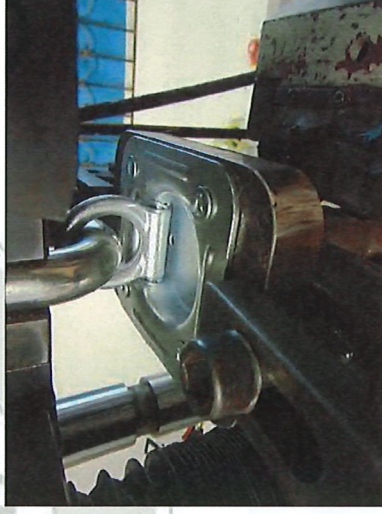
During test

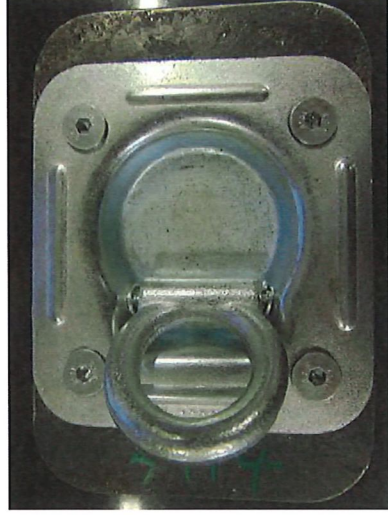
After test

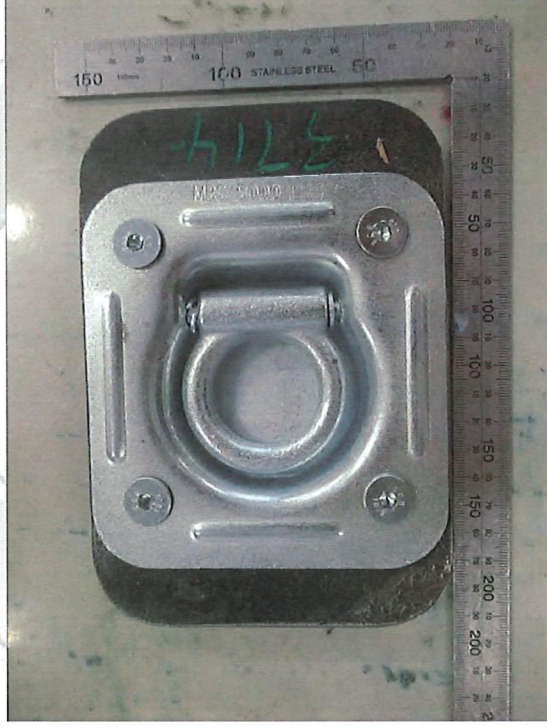
Sample photo(s):
